## Flat roof refurbishment using 100% solid Hertec 1180 Polyurea

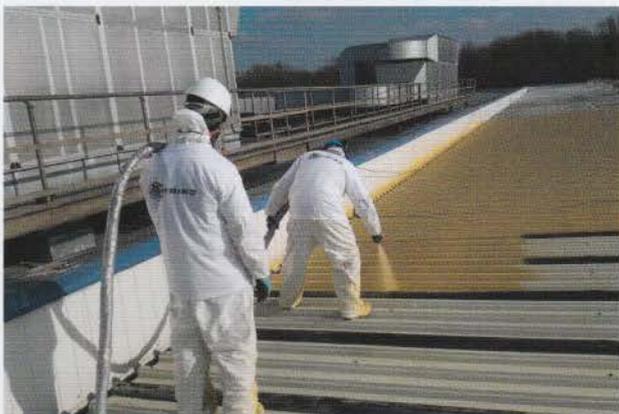
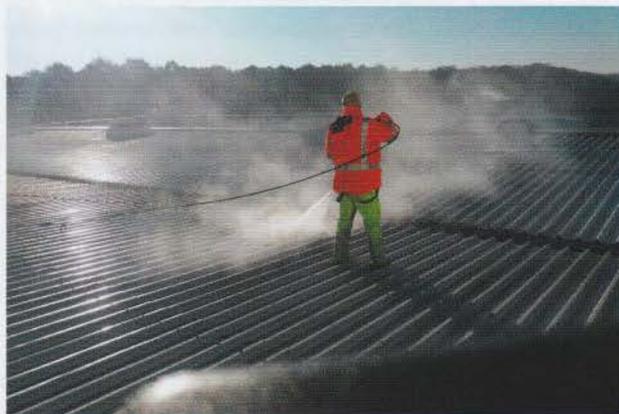
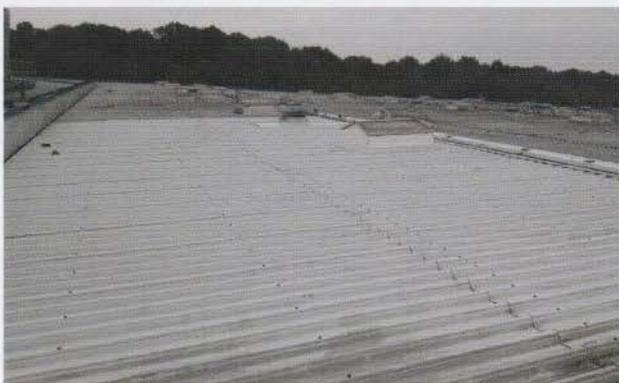
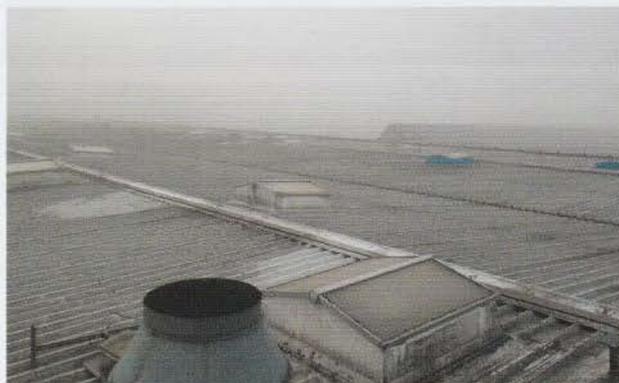
In the case of the 3 different surfaces, the surface prep, especially the substrate pre-treatment and the selected primer

types, are also of great importance. For the metal seam roof a special 1-C primer was used and for the Innox steel section, a multilayer coating construction was used to enable the necessary adhesion to the surface. It isn't easy to coat Innox steel with good adhesive properties to the polyurea, without the necessary know how. The PVC flat roof uses a 2-K melt primer, which must guarantee that the sprayed polyurea system adheres so tightly that a break between PVC and polyurea is no longer possible. This requirement profile was also met with a 2-component primer from Hercules.
