## World of Polyurea

### Case Study - Polyurea

**Project:** automotive coating/wear protection coating / interior protection - VAN (Mercedes-Benz Sprinter)

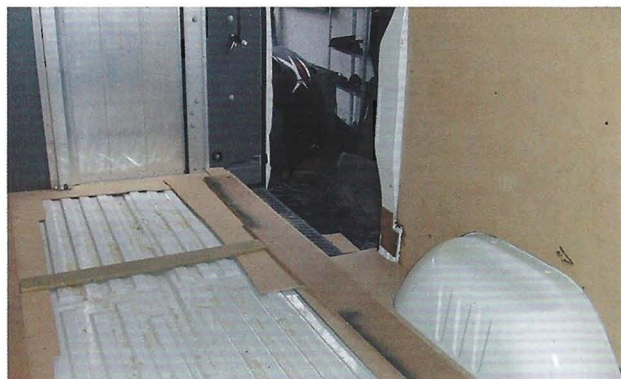
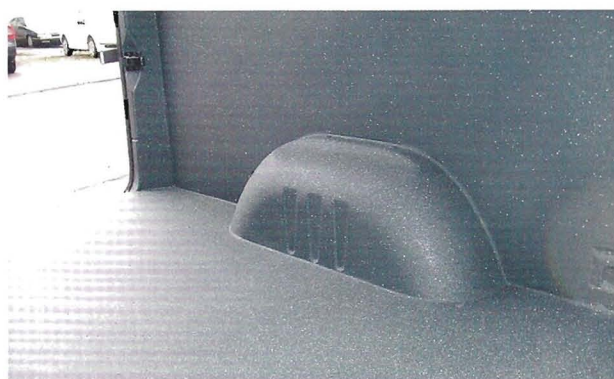
The interior of a Mercedes-Benz Sprinter needs a highly durable protective coating that must be abrasion resistant and able to minimize noise. This is why special plywood panels have been glued to the existing steel base of the van (using Hertec F 75 S Joint Filler), and then coated with a special wood primer. Hertec 1150 was used for the 2 mm coating (solid polyurea -

this product was subjected to and passed the ÖNORM EN 12053 noise emission test). This structure achieved the required flexibility in the base of the Sprinter. Finally, for visual effect, a special polyurethane was sprayed using an airless gun (known as the 'Gatter' technique) to achieve a slightly marble look finish and making the surface anti slip.
